DRONE SURVEY OF LANDSLIDE AREA NEAR TAWANG MONASTERY

INTRODUCTION:

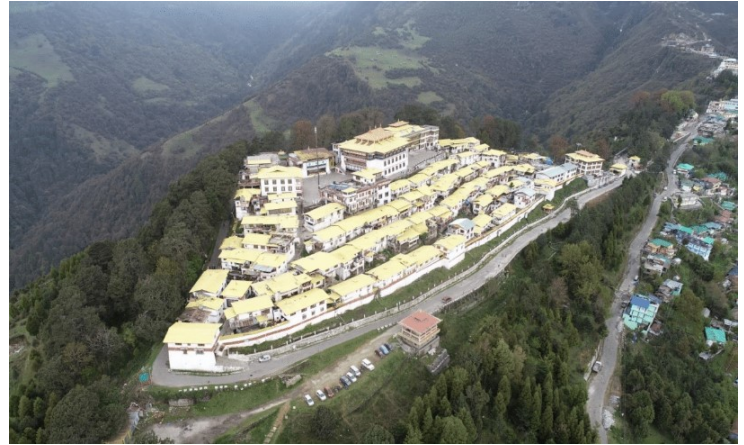
Fig.1

Tawang, a military town on the China border is a major tourist destination and Buddhist pilgrimage centre located in Arunachal Pradesh State. Tawang is perched at about 2700 meters above sea level, on Eastern Himalayas. A Catastrophic landslide occurred on 20.04.2016 near Tawang Monastery. The work of analyzing the cause of landslide and providing mitigation measures for same is being carried out by Indian Institute of Science, Bangalore. To gain better understanding and aerial view of the landslide and its topography PWD and Indian Institute of Science, Bangalore required a drone survey of landslide area to be conducted. PWD Tawang awarded Genstru to carry out drone survey for landslide affected area near Tawang Monastery. An aerial image of Tawang Monastery has been shown in **Fig.1**

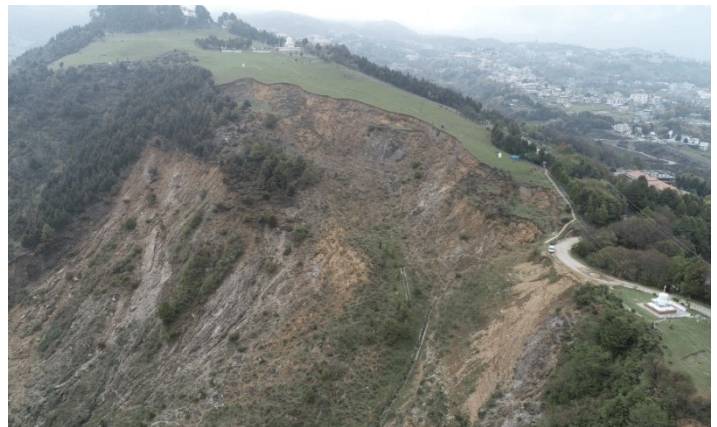
Fig.2

The drone survey was carried out to prepare 3D image of the area. The drone survey has been carried out for the area of about 1.05 Km². The length of the area surveyed is about 1500m along N-S and the width of the area is about 750m along E-W direction. The entire area has been surveyed in four different flights and the 3D model for entire area has been prepared by combining the data from all four flights. **Fig.2** shows the aerial view of landslide affected area.

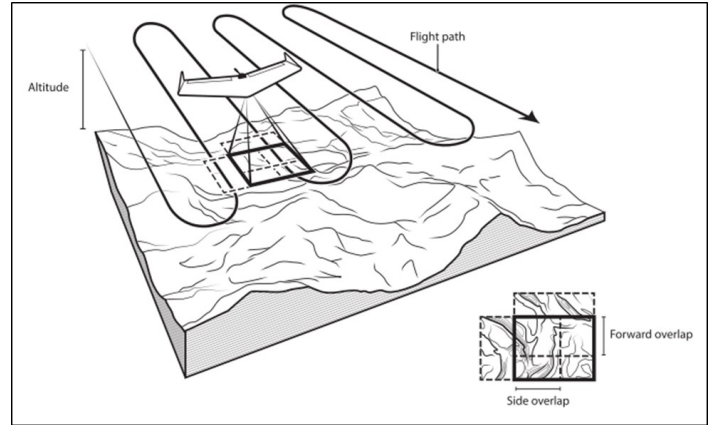
Fig.3

As the area of Tawang to be surveyed was large, it was not possible to carry the survey in single flight. In such cases it is necessary to divide the area into the parts and carry out the survey for each individual part. In this case the drone survey is carried out with four flights. **Fig 3** shows typical path followed by the drone during survey and **Fig 4.** shows 3D model generated after drone survey.
