## DIVE SURVEY, MARINE GEOTECHNICAL INVESTIGATION AND ANALYSIS FOR PROPOSED UNDERWATER REEF, MIRYA BAY

LOCATION: Mirya Bay, Ratnagiri, MH

**SCOPE OF WORK:** Four boreholes (BH) were drilled to a depth of 20 meters below the sea bed, accompanied by a dive survey.

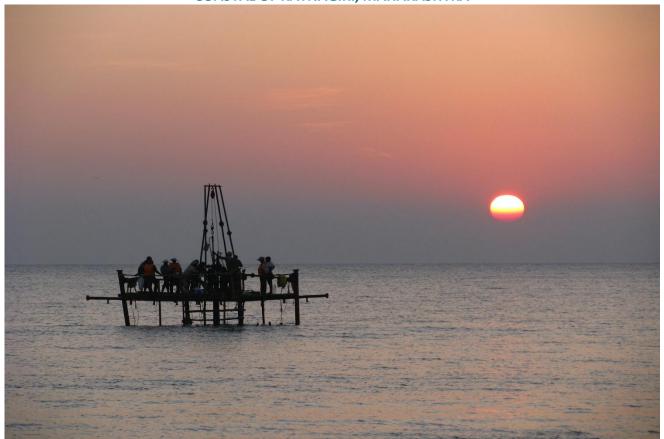
Figure 1: Drilling in Marine

- a) Necessary arrangements and mobilization of all equipment, manpower, floating paraphernalia to carry out sea bed dive survey and geotechnical investigation by conducting 4 boreholes at Mirya Bay.

- c) Carrying out sea bed analysis to understand make up of sea bed.
- d) Conducting 4 boreholes at proposed location of submerged reef up to 20m depth, in an open sea.

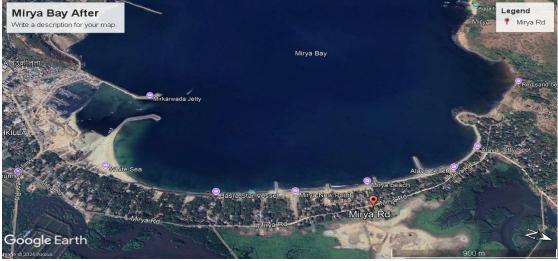
Figure 4: After completion of protection work
